**MARYLAND HISTORICAL TRUST
NR-ELIGIBILITY REVIEW FORM**

Property Name: Dutrow-Thomas Farm Inventory Number: F-1-175

State Historic Sites Inventory Form

historic Dutrow-Thomas Farmstead (preferred); Red Hill

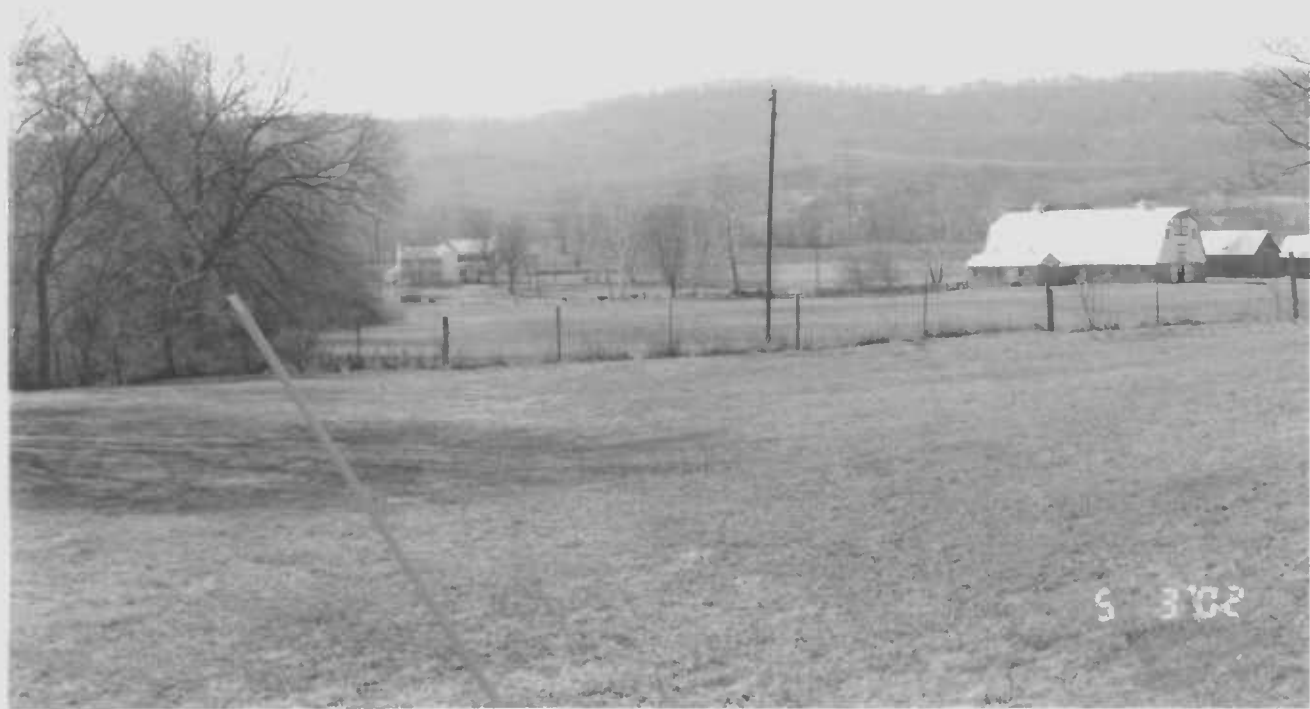
1/3

Overview, view W

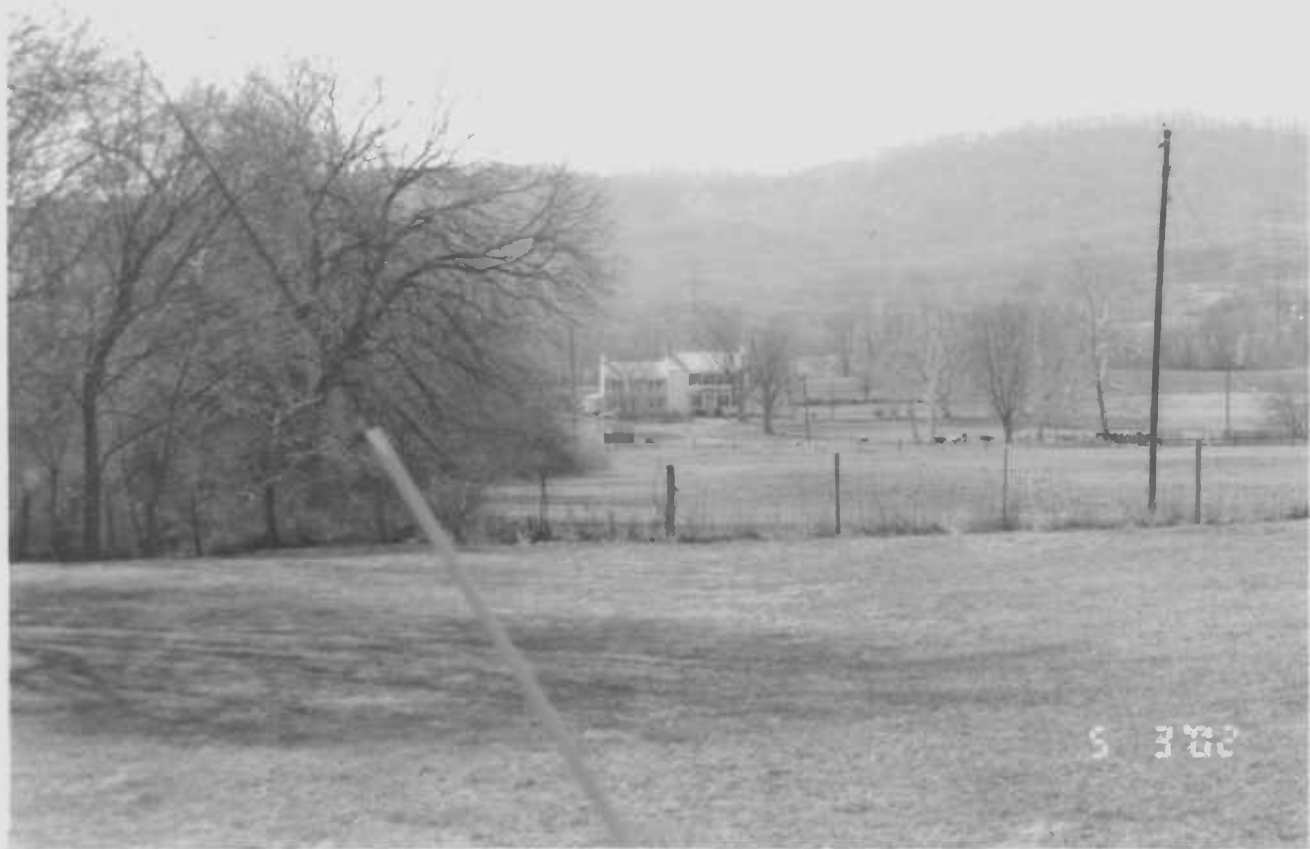
2/3

Dwelling, view W

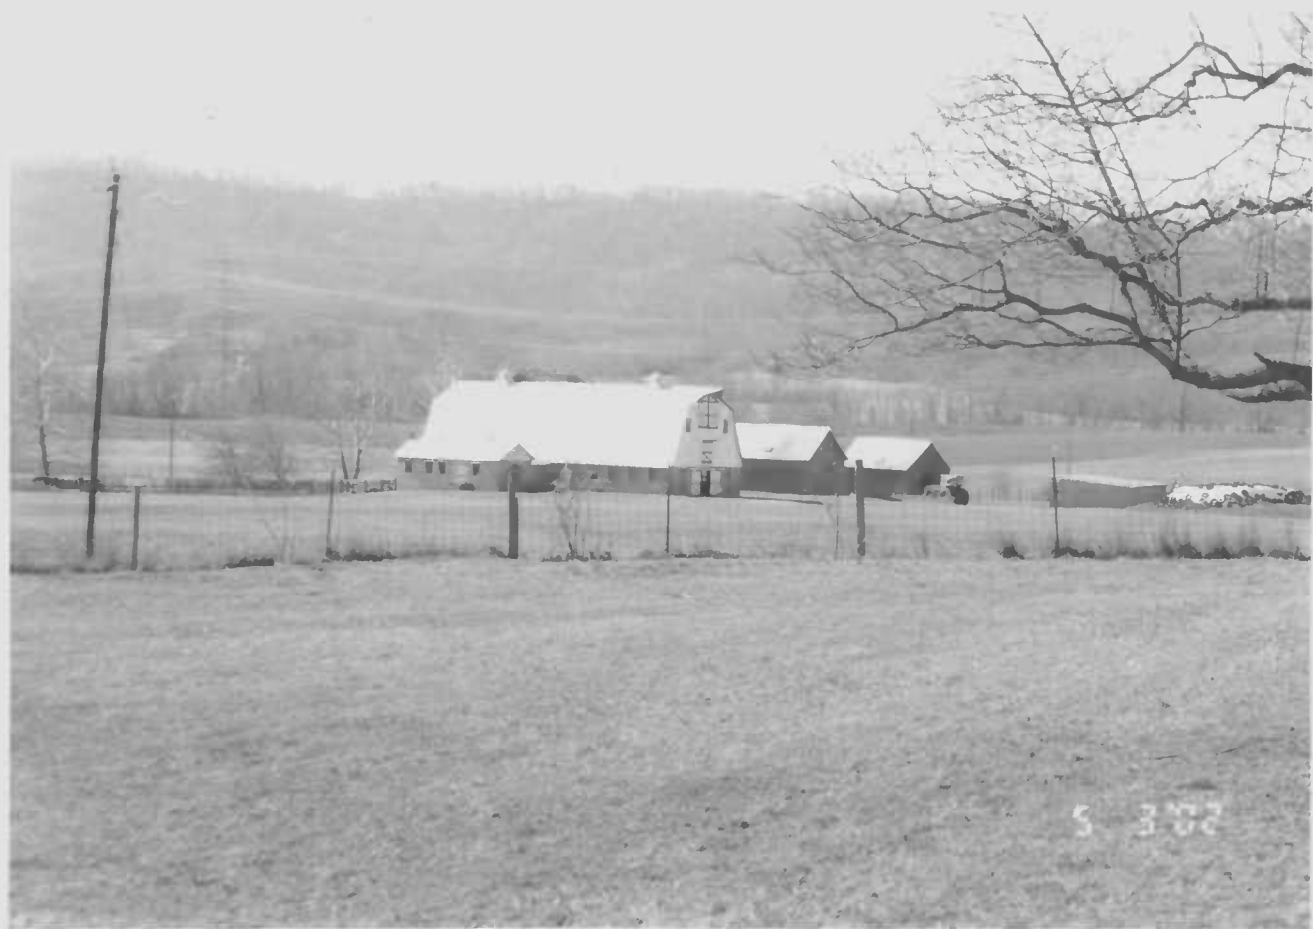
3/3

Barns, view W

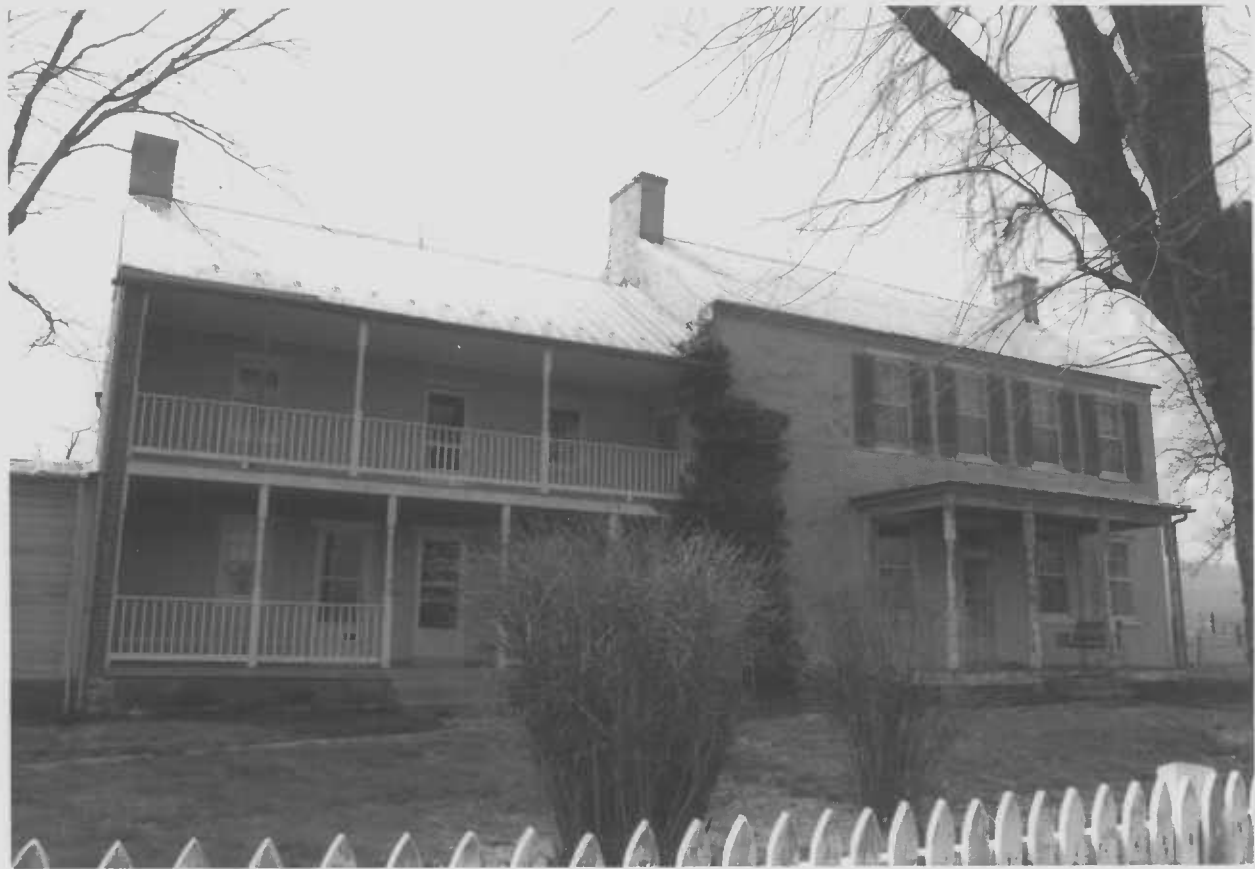
1/13

The house is a two-story brick building facing east with a two-story side service wing on the south gable end of the four-bay main section. The walls are laid in 5:1 American bond and interior chimneys are located at the north and south gable ends. The roof is standing seam metal. The cornice is corbeled, and the window and door openings have wood lintels with bull's-eye corner blocks. The windows are 6/6 with louvred shutters. The first story is sheltered by a flat roofed porch with turned columns, probably an addition made in the last quarter of the 19th century. The entrance is in the left center bay and has a 10-panel door with a transom featuring diamond patterned muntins. The side wing has a recessed east wall fronted by a two-level open porch. Two entrances occupy the center bays of the four bays on the first story of the side wing and a third entrance is in the end wall of the main section. On the west elevation of the house are two modern additions, one located off the side wing and the other a sun room off the main section.

East elevation

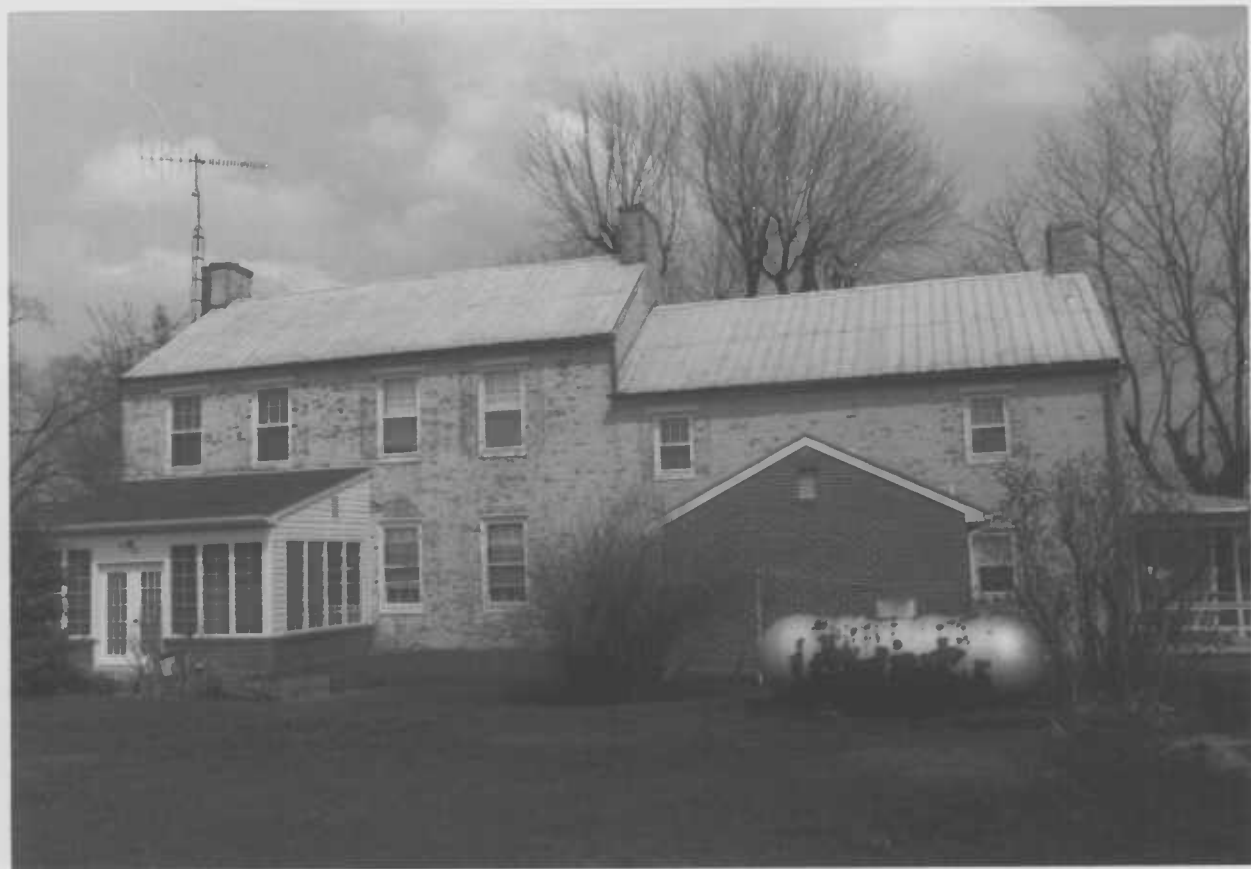
2/13

West elevation

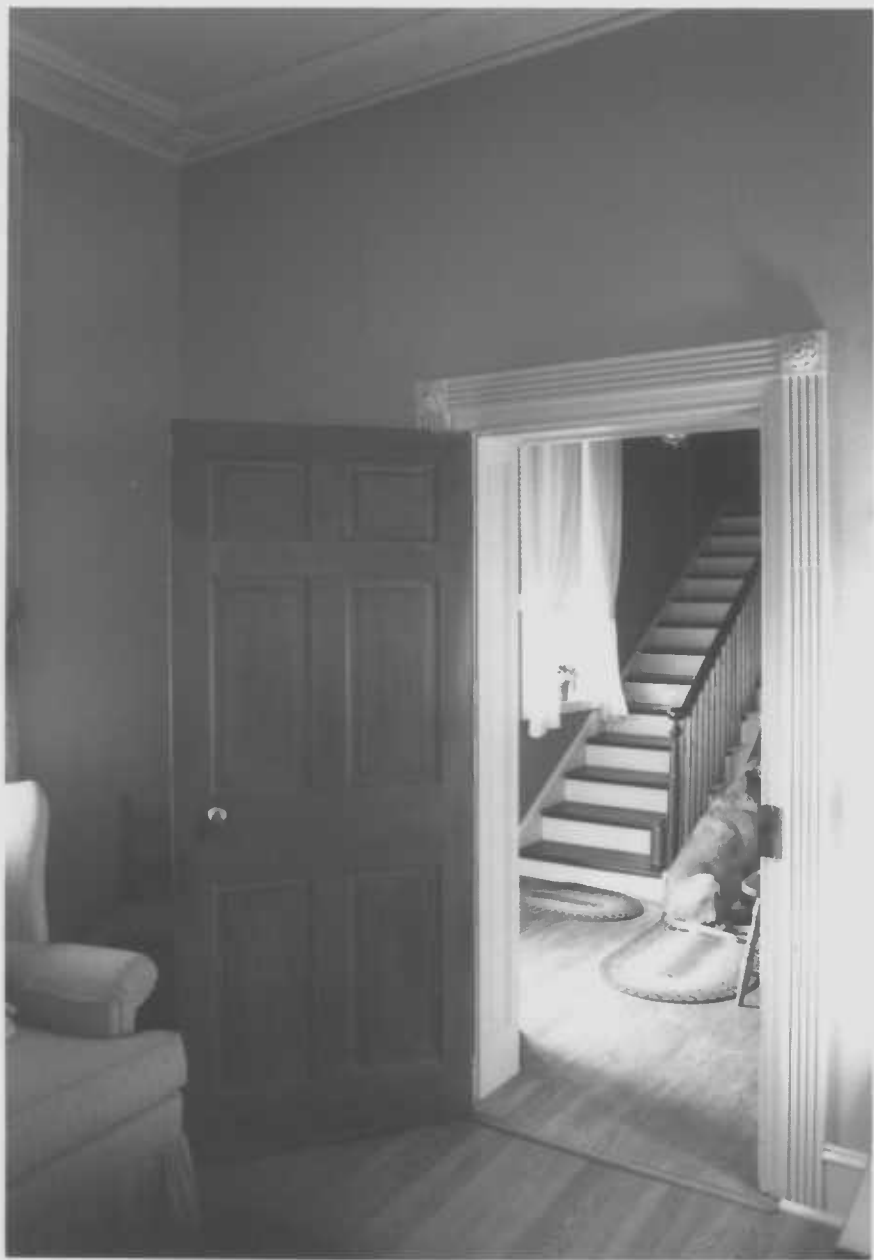
3/13

The interior plan of the house reveals a cross hall in the main section in which the staircase is located against the east wall, rising past the window in the outer bay. The rest of the main section's first floor is occupied by two rooms, a parlor on the north end and the probable original dining room located off the long side of the stair hall. The interior details of the main section show the transition between the Federal style and the Greek Revival style. In the stair hall, the closer is ornamented with a scroll design. The interior doors are grained and the entrance to the parlor has a paneled soffit. The parlor, a 24 by 17-ft. room, has a plaster molded cornice and the ceiling originally had a molded plaster center medallion which has been removed because of deterioration. The brick mantel is a modern feature, replacing the original mantel. The window and door surrounds have rosette corner blocks and reed molding surrounds. The floor in both the parlor and the hall is covered with hardwood installed in the 1950's. The walls are painted plaster. The west wall has two bays with a 10-panel door which formerly opened to the outside, but now leads to the modern sun room. The former dining room has wallpaper and a Greek Revival style molded mantelpiece flanked by a built-in grained cupboard. This cupboard has a vernacular version of a broken pediment with simp.

Parlor doorway and staircase

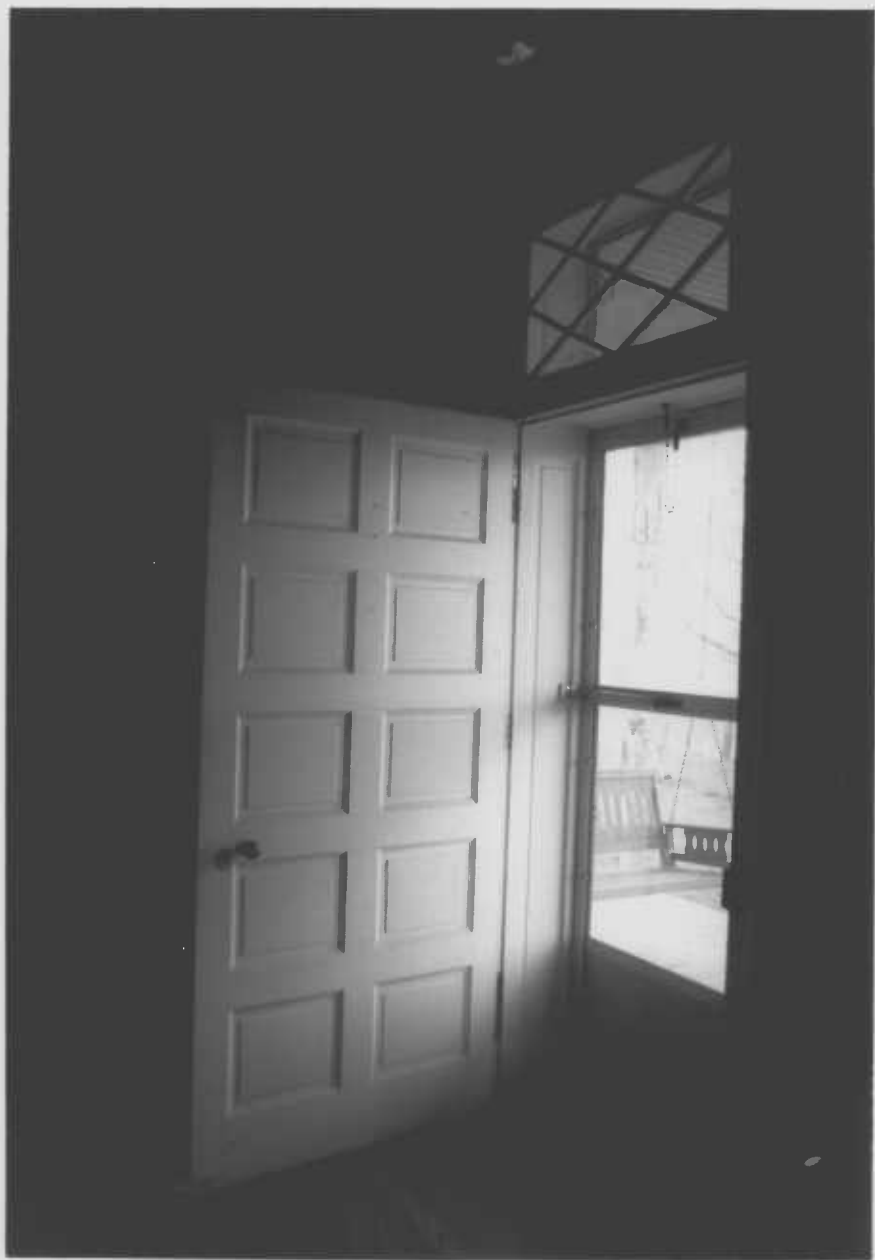
4/13

Main door detail

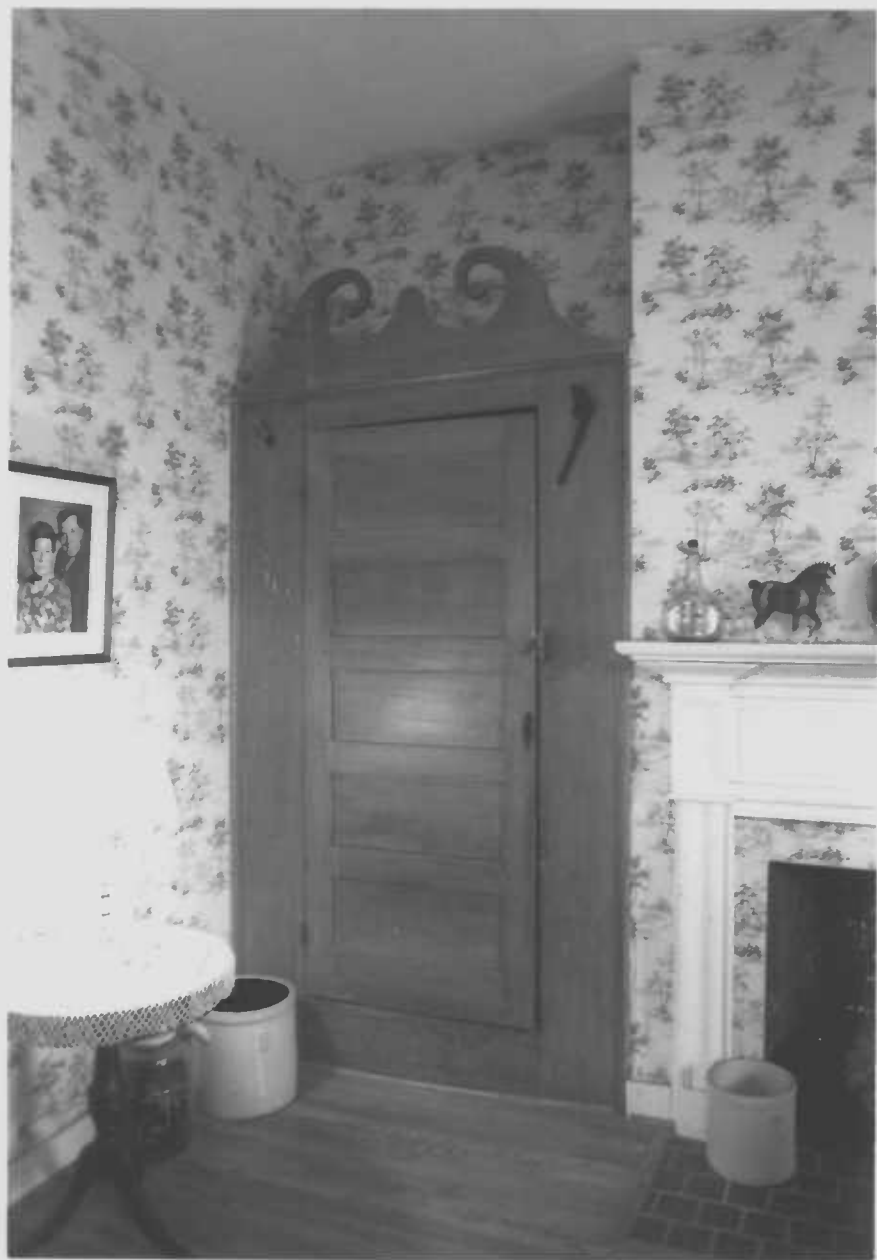
5/13

Dining room cupboard

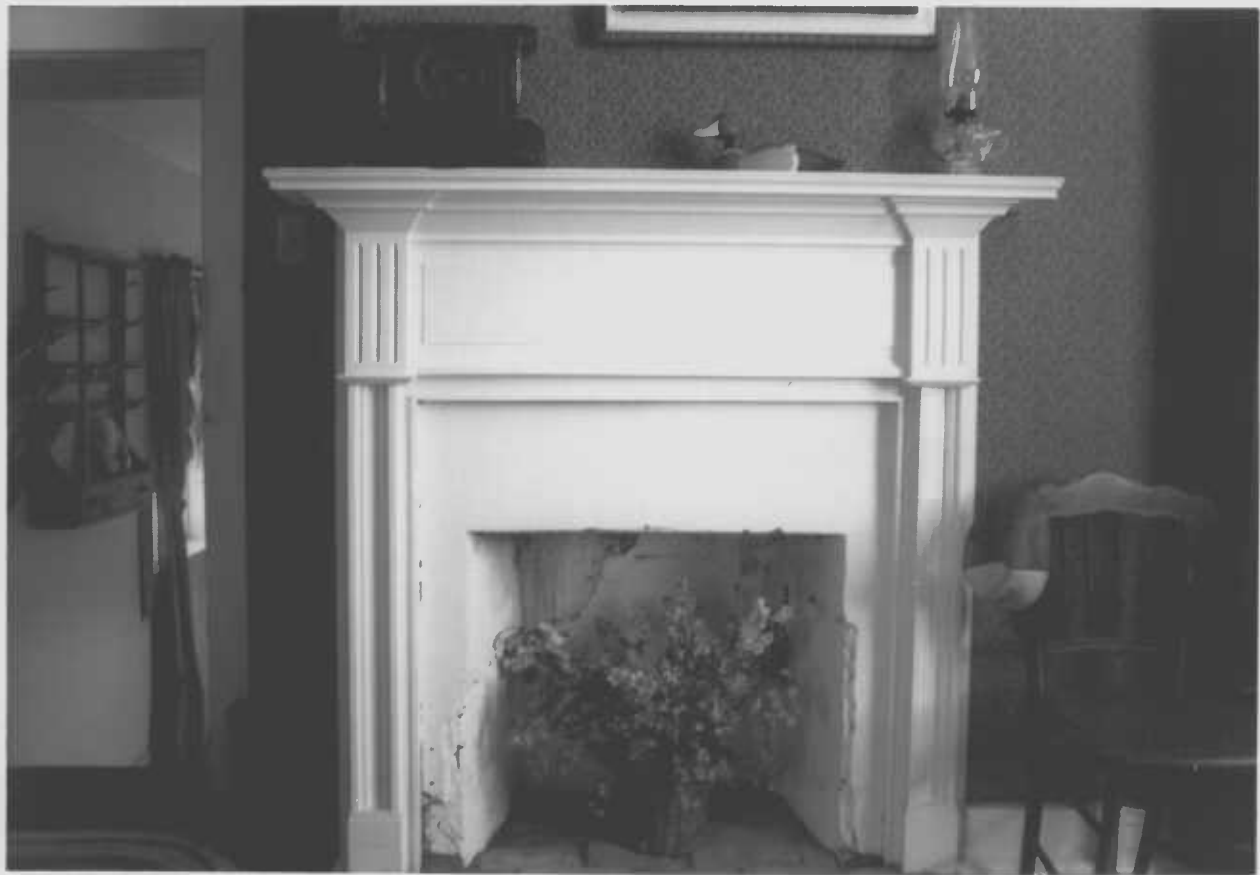
6/13

Second floor mantel

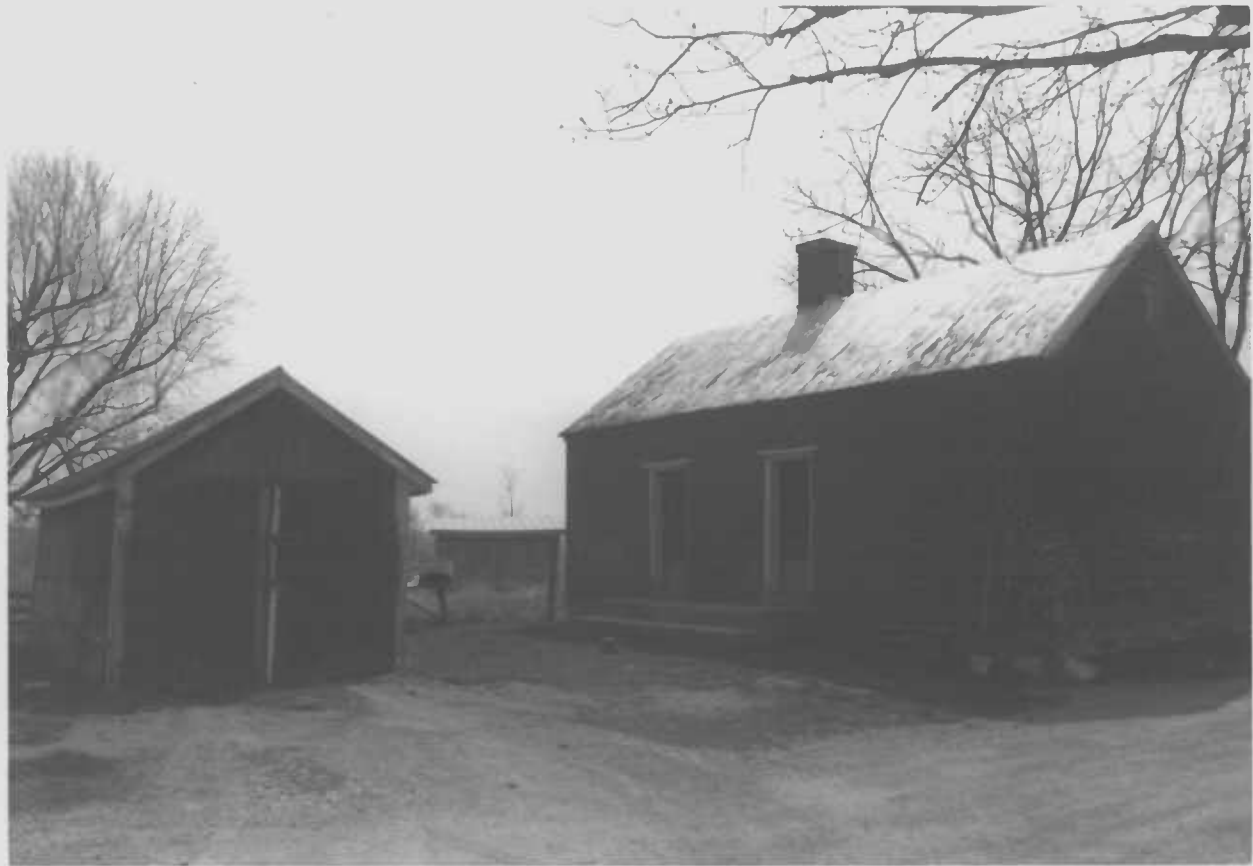
7/13

Slave quarters: The one-story brick building is identified by Mrs. Thomas as slave quarters rather than a summer kitchen and this is supported by its siting somewhat further from the house than the typical summer kitchen location and by its interior finish. The building is also 5:1 bond as is the main dwelling. The corrugated metal gable roof covers original wood shingles and an off-center chimney rises from the roof. The building has two rooms, the northern having a large open fireplace with a blackened Federal style mantel with a fluted frieze panel. Winding stairs lead to the upper level loft. A 6/6 window is located next to the 4-panel door in the east elevation and a second window is in the west elevation. The other room in the building apparently served as a storage room, with open shelves around the walls. The floor in this room, as in the other room, is wide boards, but is much deteriorated. The building most recently was used for butchering activities. The quarters were probably built at the same time as the house, about 1835.

Garage: Immediately east of the slave quarters is a frame garage built about 1890-1900 with tongue-and-groove siding, a standing seam gable roof, and double swing doors.

Garage and slave quarters/summer kitchen,
view from east

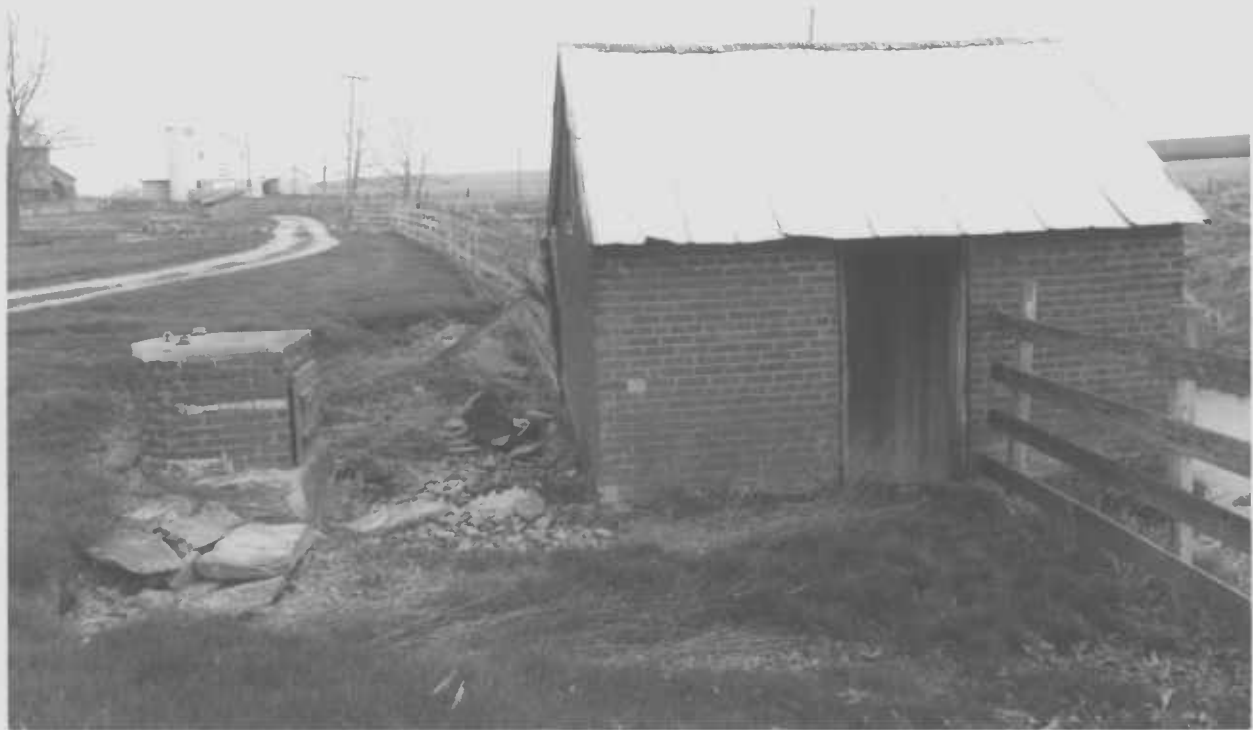
8/13

Springhouse: The brick springhouse is located on the east side of the driveway between the domestic and agricultural groups. It was probably built in the

1830's with the main house and the slave quarters. It has 5:1 American bond walls and a tongue-and-groove door on the west elevation. The gable roof is covered with standing seam metal. The spring is located just west of the building and flows through the foundation into a trough in the ground level.

Springhouse, west elevation

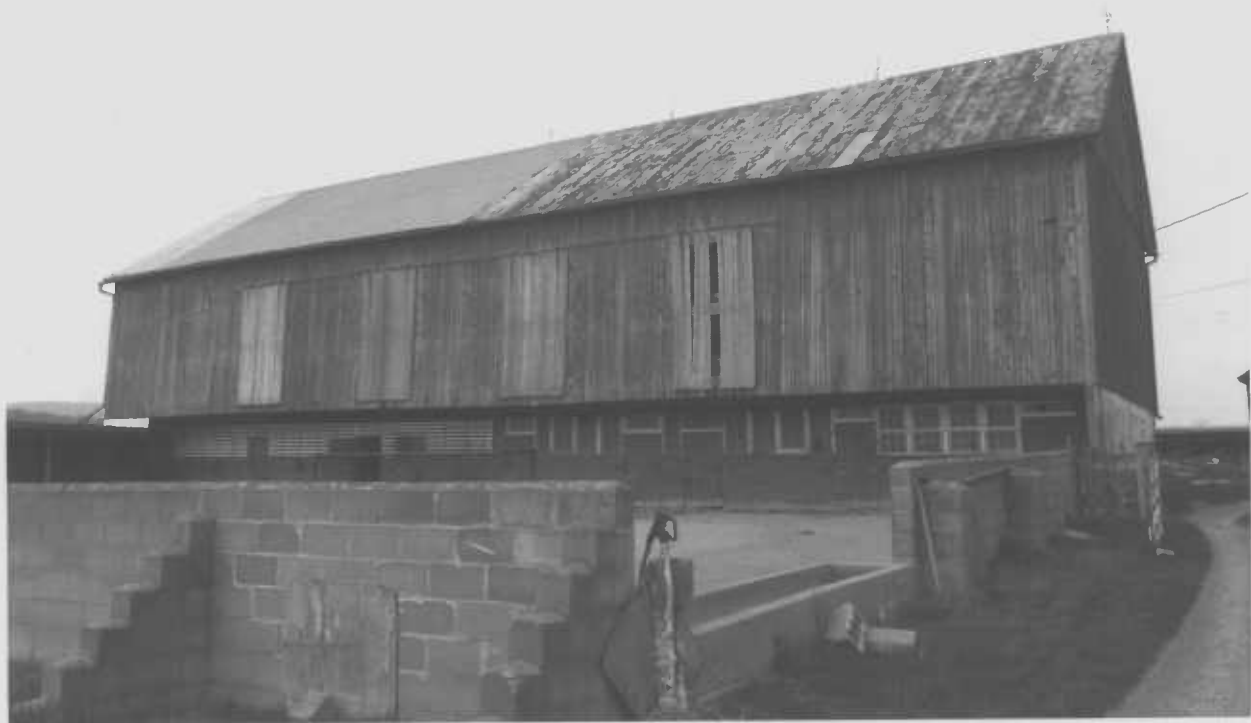
9/13

Bank barn: The frame bank barn with a stone foundation was built in 1913, according to Mrs. Thomas. It is 112 feet by 60 feet and is reputed to be one of the largest in southern Frederick County. It has vertical board siding and a corrugated metal roof. The stall level on the south elevation is enclosed by horizontal boards in both flush and open applications. The barn has four sliding doors on the south elevation and two sets of similar doors on the north elevation.

Bank barn, west elevation

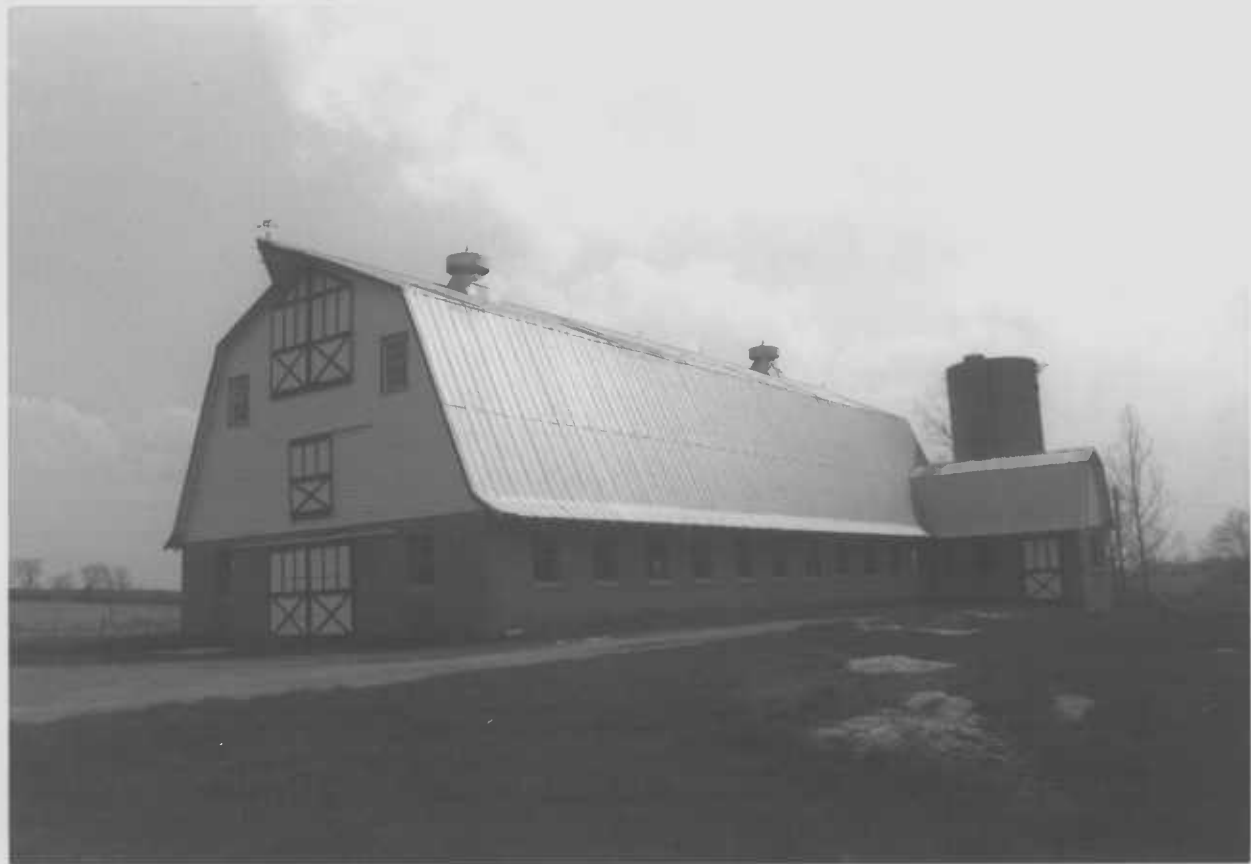
10/13

Dairy barn, milk house, and silo: The concrete block dairy barn, milk house, and silo were built about 1950 and are non-contributing structures in the farmstead.

Dairy barn, north elevation

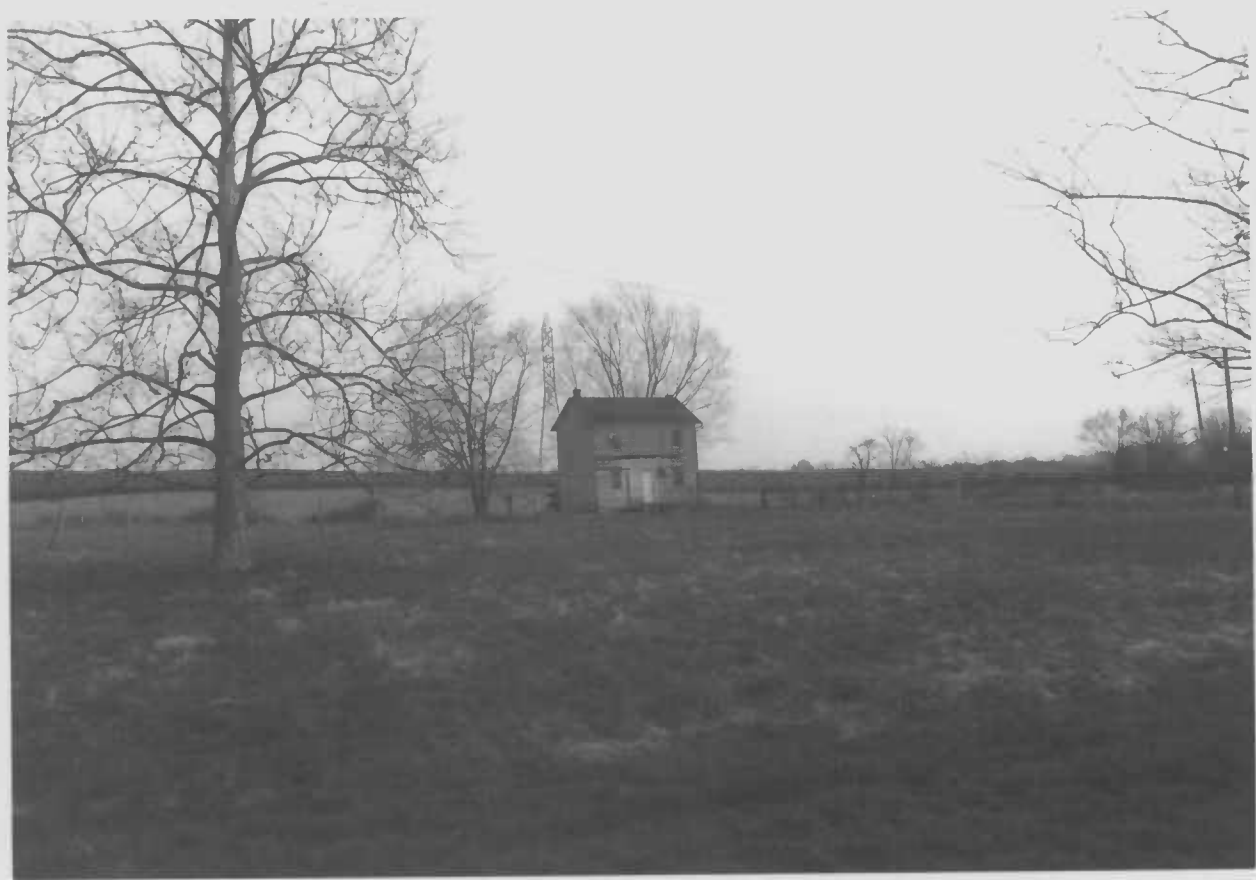
11/13

Tenant house: The frame tenant house is unoccupied and deteriorating, standing in a field about 50 yards east of the driveway between the domestic and agricultural groups. It was not observed in detail, but appears to have artificial siding over original german siding and the outline of a one-story porch, now missing on the west elevation. The main elevation has three bays on the first story with a center entrance and two bays on the second story. The roof is standing seam metal and an interior chimney is located on the north gable end. The house appears to have been built during the period 1875-1900. Mrs. Thomas plans to demolish the house by controlled burn under fire company supervision.

Tenant house, view from west

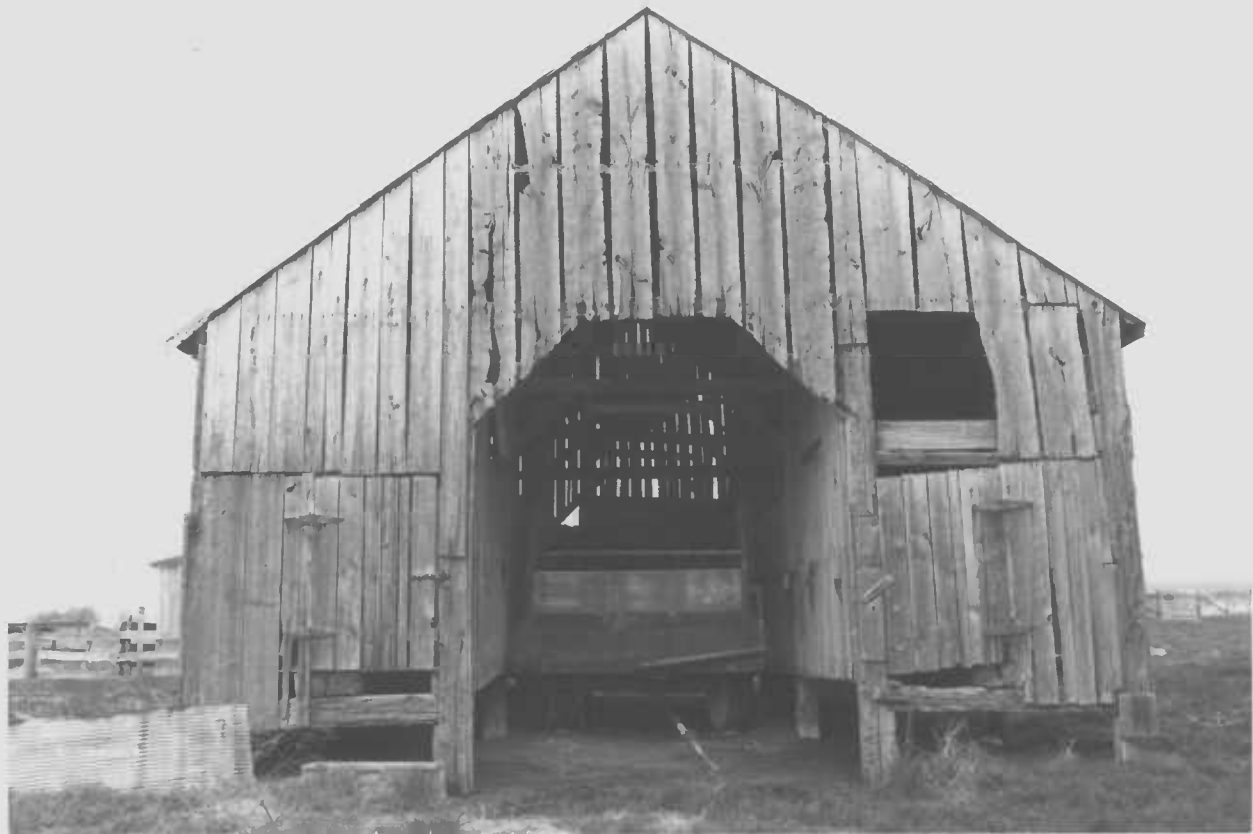
12/13

Wagon shed/corn cribs: Two frame wagon sheds are located north and northeast of the bank barn. The older of the two was probably built in the last quarter of the 19th century and has a narrow drive through opening with larger cribs flanking the opening. The newer of the two has a wider opening and correspondingly narrower cribs. Both have vertical siding and corrugated metal roofs. The older wagon shed has an intact wood pulley for changing wagon carriages to serve varied agricultural tasks, such as closed bed to flat bed.

Late 19th century wagon shed/corn crib, south
elevation

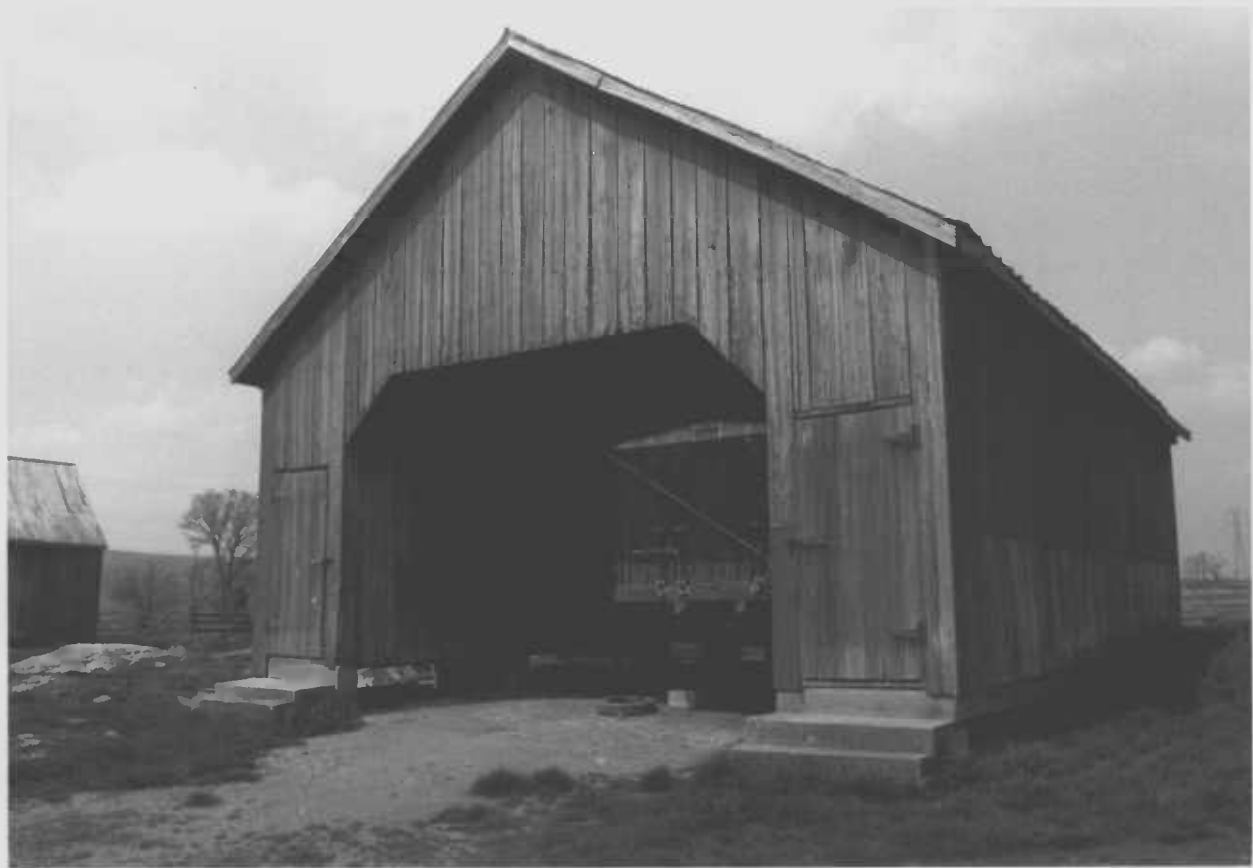
13/12

Circa 1940 wagon shed/corn crib, south-
east corner view
